Operating Experience Weekly Summary 97-22

May 23 through May 29, 1997

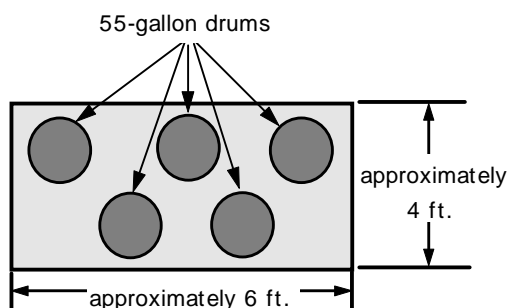
Figure 1-1 Top View of "White Metal Box"

Investigators determined that the white metal box contained low-level radioactive legacy waste. Waste handlers had packaged the box earlier in the week for shipment to the Nevada Test Site. The box contained five, 55-gallon drums of waste material without lids. Additional waste material was stored between the drums as filler (see figure 1-1). The box was on the bottom of a three-high stack of white metal boxes.

Investigators determined that some of the waste in the box contained high concentrations of uranium nitrates, chlorides, and water. They believe that the over-pressurization was caused by a chemical reaction between wastes placed in the box. As an immediate corrective action, the facility manager suspended all site operations involving packaging of multiple waste streams. Between 1990 and 1997, Fernald workers shipped over 100,000 containers or approximately six and a half million cubic feet of waste to the Nevada Test Site. Department of Energy personnel notified Nevada Test Site personnel of the event and recommended evaluation of containers with similar waste streams. The facility manager also directed facility personnel to revise the procedure that controls packaging of residues to ensure that mixing of intermediate materials is addressed. Investigators continue to assess the event to determine the exact cause of the reaction. Lessons learned from this event include the importance of (1) not mixing incompatible materials, even if approved in a procedure; (2) evaluating materials; and (3) ensuring procedures govern the chemicals that can be packaged together to preclude unwanted interactions.

These events highlight the need for managers of facilities that generate and receive waste materials containing chemicals to develop appropriate programs and procedures to identify chemical compatibility. These programs should consider safe handling, storage, and transportation requirements. Facility managers should ensure that workers are familiar with facility safety precautions and emergency procedures and should provide workers with the necessary information to ensure accurate compatibility evaluations. Hazardous chemicals must be identified and their risks understood. Risks should be evaluated, and barriers should be put in place to reduce them. In facilities where hazardous chemicals are processed, workers should be trained in handling chemicals and their potential reactions. Personal protective equipment must be selected in accordance with the magnitude of the hazard and training must be provided in the proper use of the equipment.
